INDOOR AIR QUALITY ASSESSMENT

**Fitchburg District Court
100 Elm Street
Fitchburg, Massachusetts**

Prepared by:
Massachusetts Department of Public Health
Bureau of Environmental Health Assessment
November, 2001

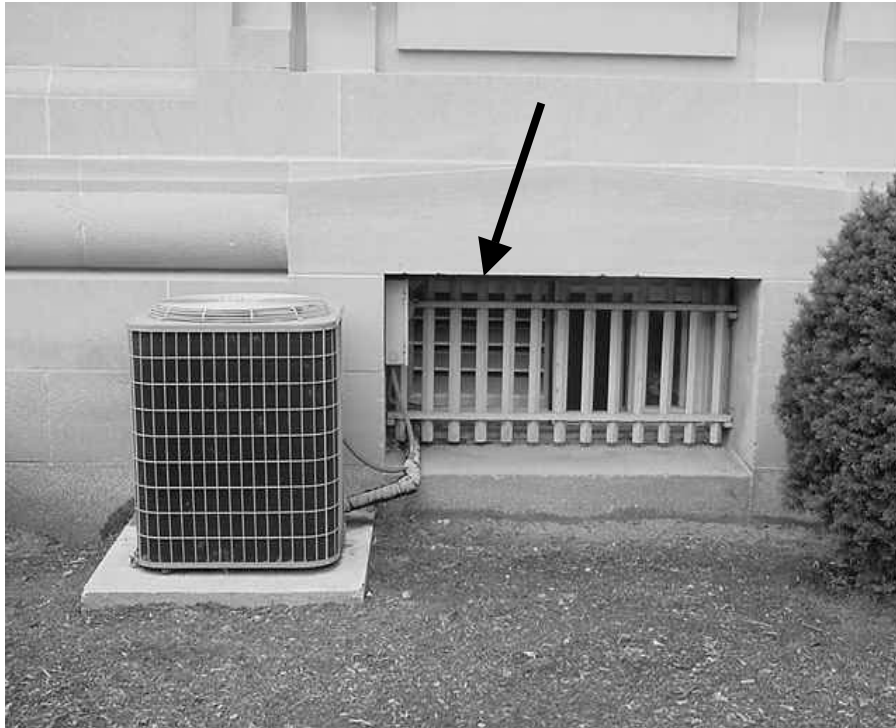
Picture 2

Basement AHU Fresh Air Intake Located at Ground Level

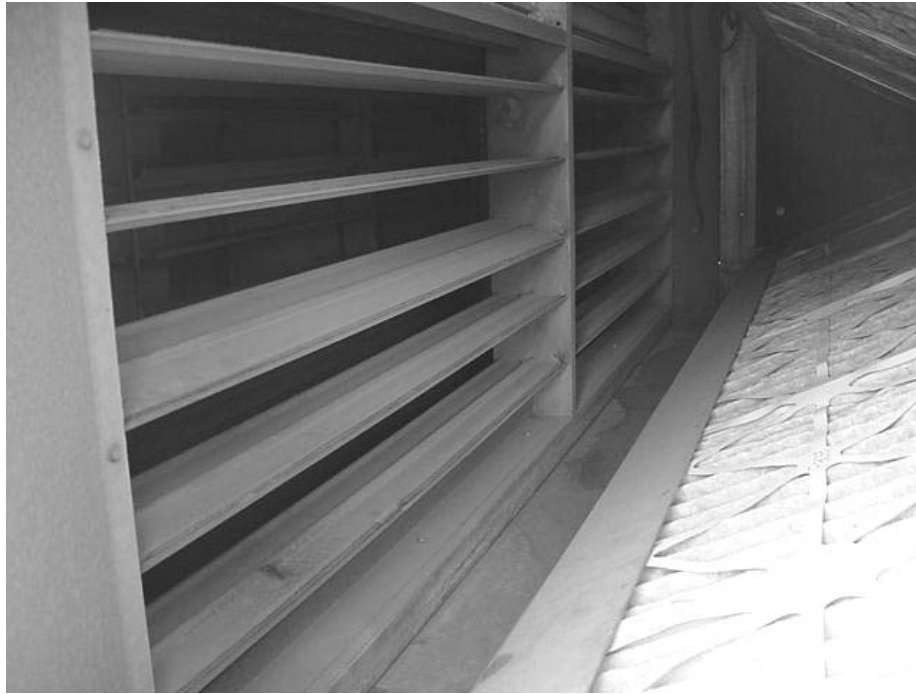
Picture 4

Rooftop AHU Had its Return Air Intake Louvers Open

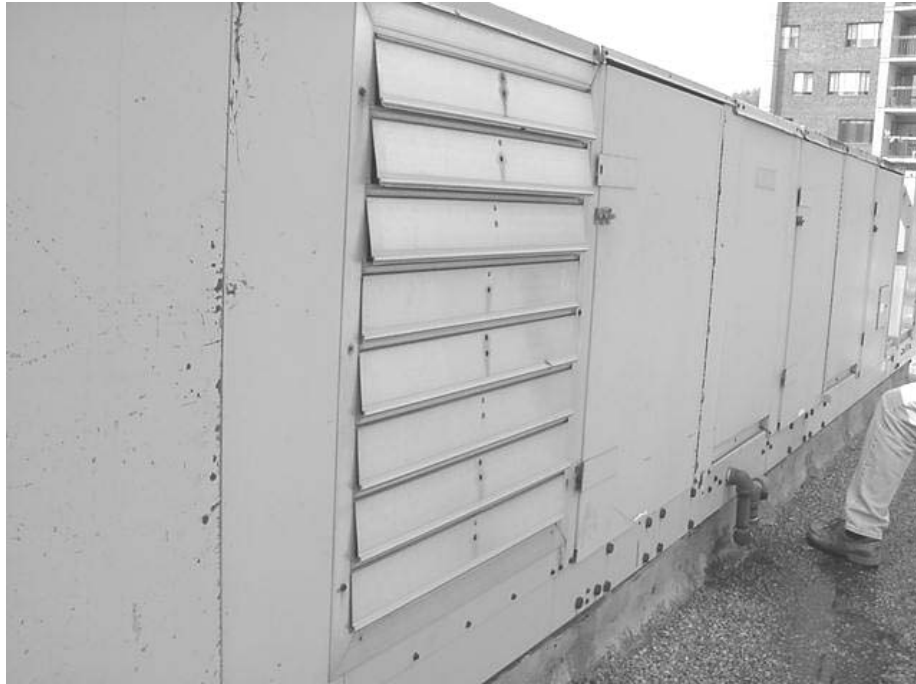
Picture 5

The orientation of the AHU can produce conditions that allow for uncontrolled entrainment of cold air during winter months through the passive exhaust vent. The passive exhaust vents face east. New England is prone to winter storms with high northeast winds (Nor'Easters). As NE winds blow across the face of the rooftop AHU, this airflow can lift the edge of the passive vents and force air in an uncontrolled manner into the return air chamber. This is enhanced by lifting of the exhaust vent louvers when

return vent louvers restrict airflow. In the winter this can introduce cold air that may result in the AHU coils freezing.

Passive Louver Exhaust Vent of Rooftop AHU

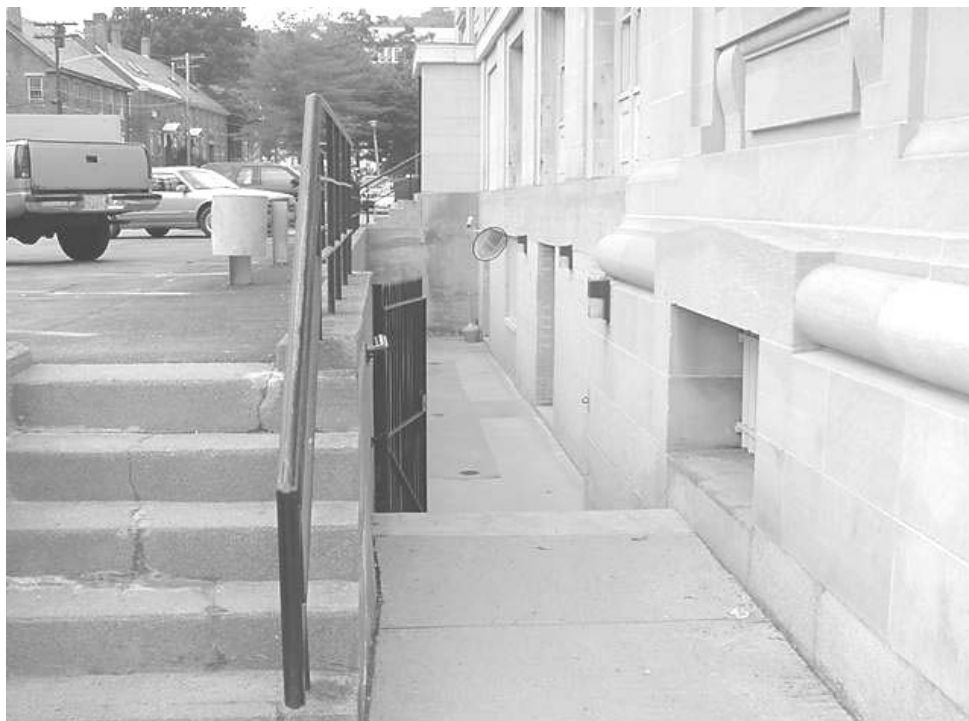
Picture 6

Recommendations concerning remediation of flooding in the basement offices were previously made to the Honorable Barbara Dortch-Okara (MDPH, 2001, Attachment A). The configuration of the building makes the rear walkway prone to flooding damage. The rear of the building has a walkway that slopes down from the street to a door that serves as the entrance for the cellblock (see Picture 6). The top of the walkway connects to a sidewalk that slopes from the rear of the building to the front (see Picture 7). With extreme heavy rain, water rushing down the sidewalk can be directed to accumulate in the sunken walkway. If the rate of water entering the walkway exceeds the drainage rate of the drains, the water level can rise and enter the cell block doors. According to building staff, rainwater entered the ground floor through this door.

Sunken Walkway at Rear of the Building

11. Consideration should be given to installing a raised section between the sidewalk and the stairs for the sunken walkway to serve as a barrier to runoff from the sidewalk/street.

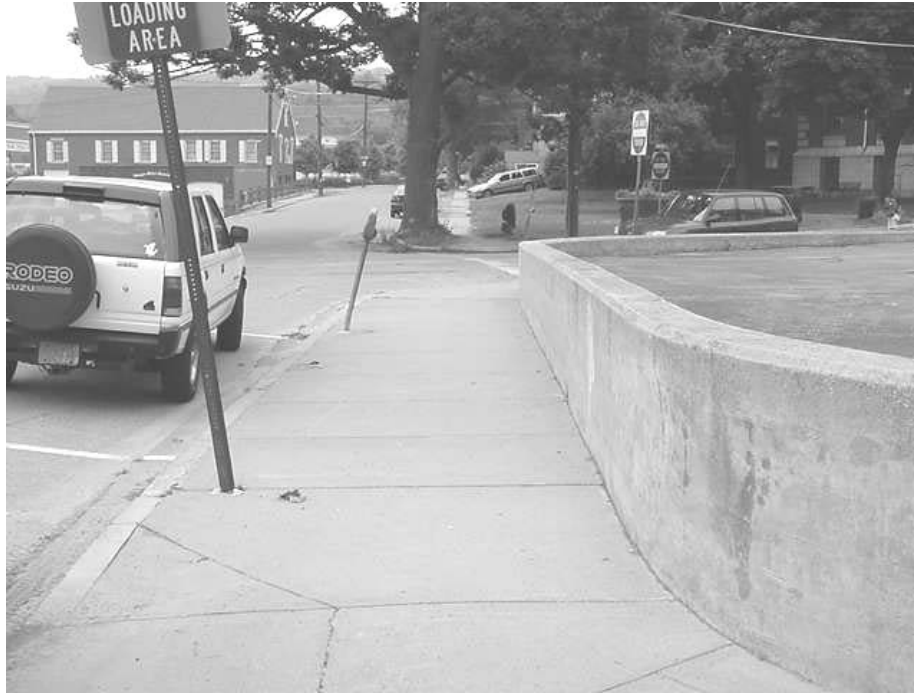
Picture 7

Sidewalk That Slopes Towards the Sunken Walkway at the Rear of the Building

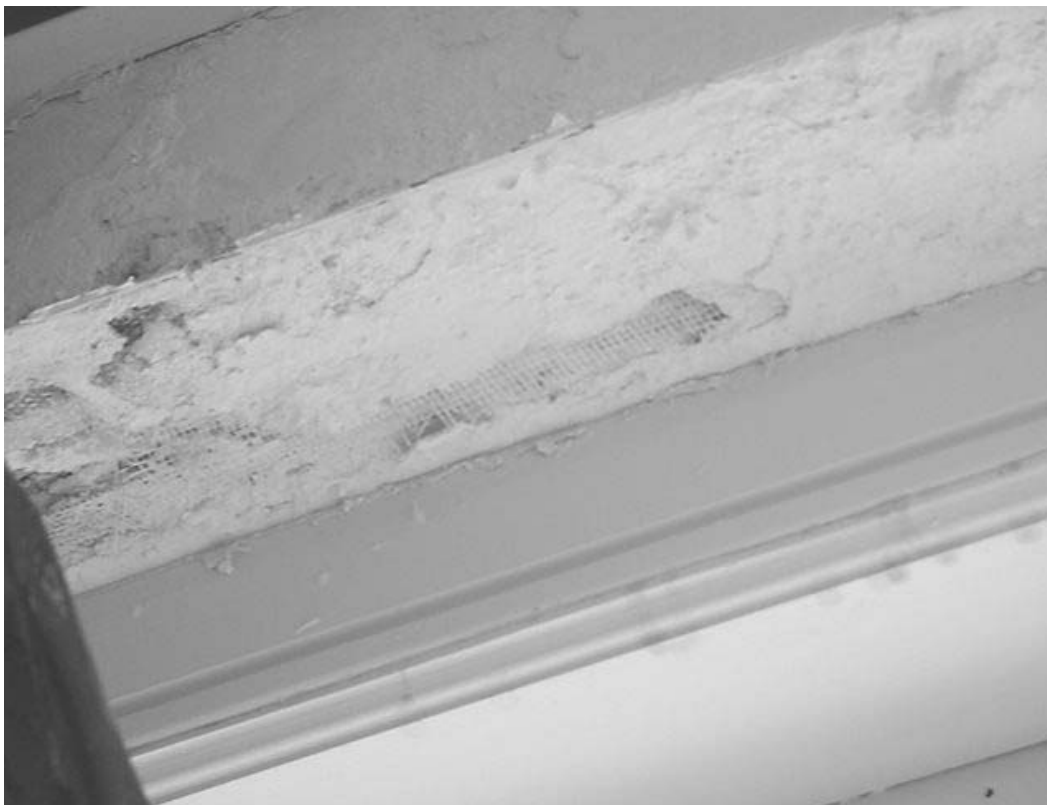
Picture 8

Water damage to the ceiling in several areas on the north side of the building was noted. In one office water damage has eroded ceiling plaster from the lathe (see Picture 8). Water damage appears to correspond to an area of the roof that has damaged roof flashing (see Picture 9). An interior, paneled wall of the second floor courtroom was warped from water damage (see Picture 10). The water damage in one courtroom appeared to be below an abandoned pipe in the ceiling plenum (see Picture 11). Building officials reported that they have been working with a roofing contractor to try to isolate and repair the leak. Water-damaged ceiling tiles and other porous building materials can provide a source of microbial growth and should be repaired/replaced after a water leak is discovered.

Eroded Ceiling Plaster, Note Exposed Lathe

5. Repair roof/plumbing leaks and replace any remaining water-stained ceiling tiles and building materials. Examine the area above and around these areas for microbial growth. Disinfect areas of water leaks with an appropriate antimicrobial.

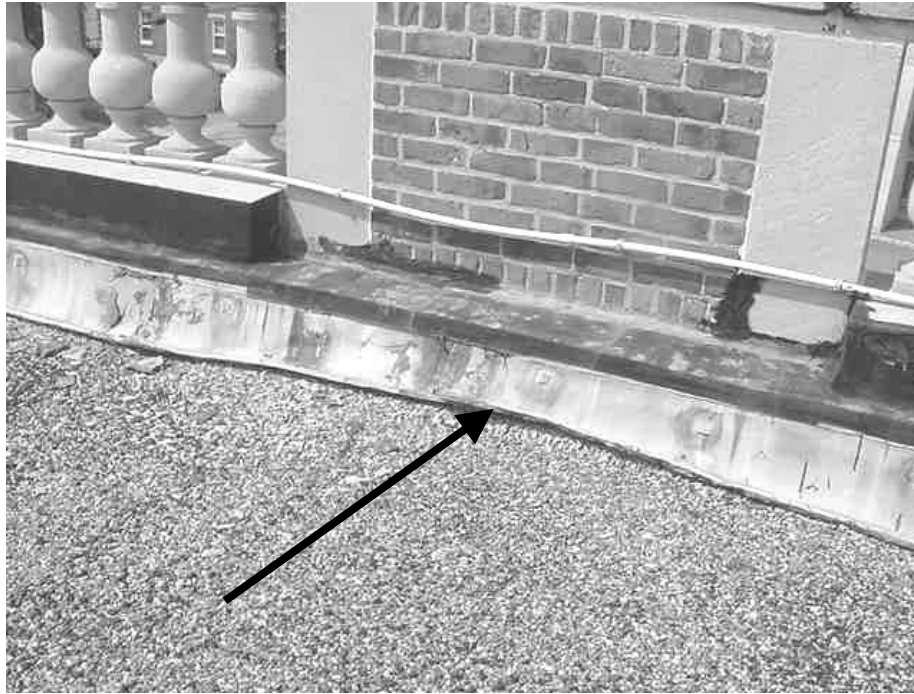
Picture 9

Lifted Roof Flashing above Water Damage on the Second Floor

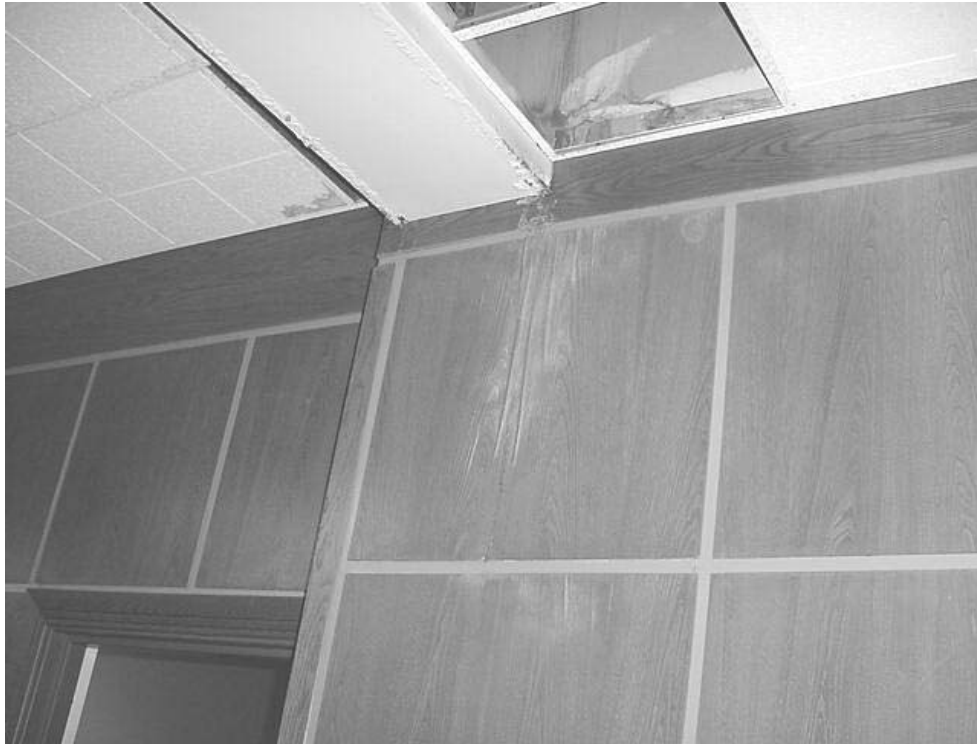
Picture 10

Water Damaged Interior Wall Paneling of the Second Floor Courtroom

6. Once the roof/plumbing leaks are repaired, repair plaster and wall paneling in courtrooms.
7. For buildings in New England, periods of low relative humidity during the winter are often unavoidable. Therefore, scrupulous cleaning practices should be adopted to minimize common indoor air contaminants whose irritant effects can be enhanced when the relative humidity is low. To control for dusts, a HEPA filter equipped vacuum cleaner in conjunction with wet wiping of all surfaces is recommended. Drinking water during the day can help ease some symptoms associated with a dry environment (throat and sinus irritations).

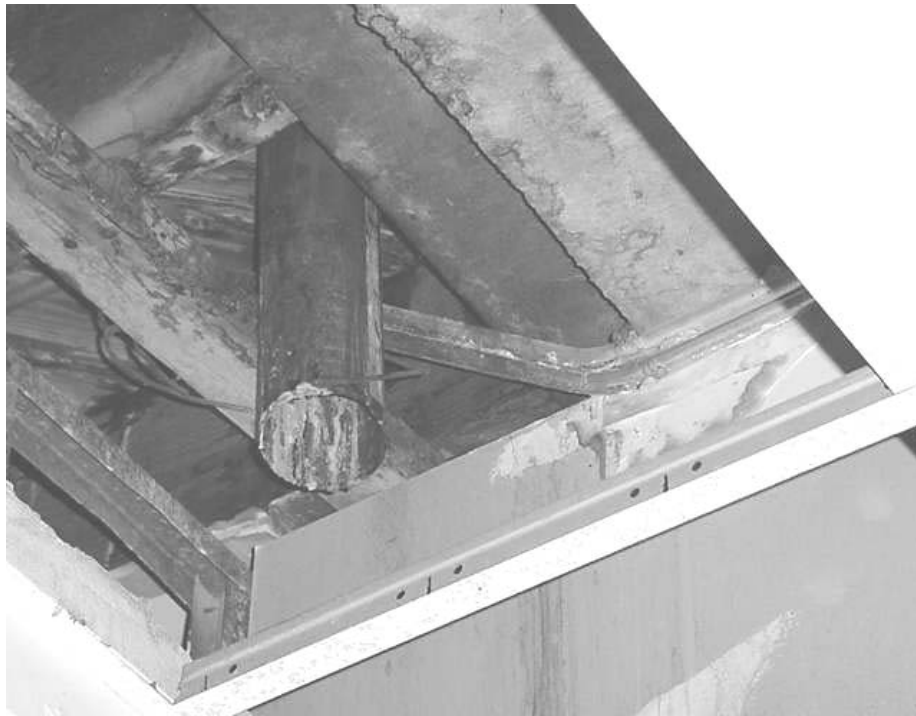
Picture 11

Abandoned Pipe in the Ceiling Plenum above Water Damaged Paneling

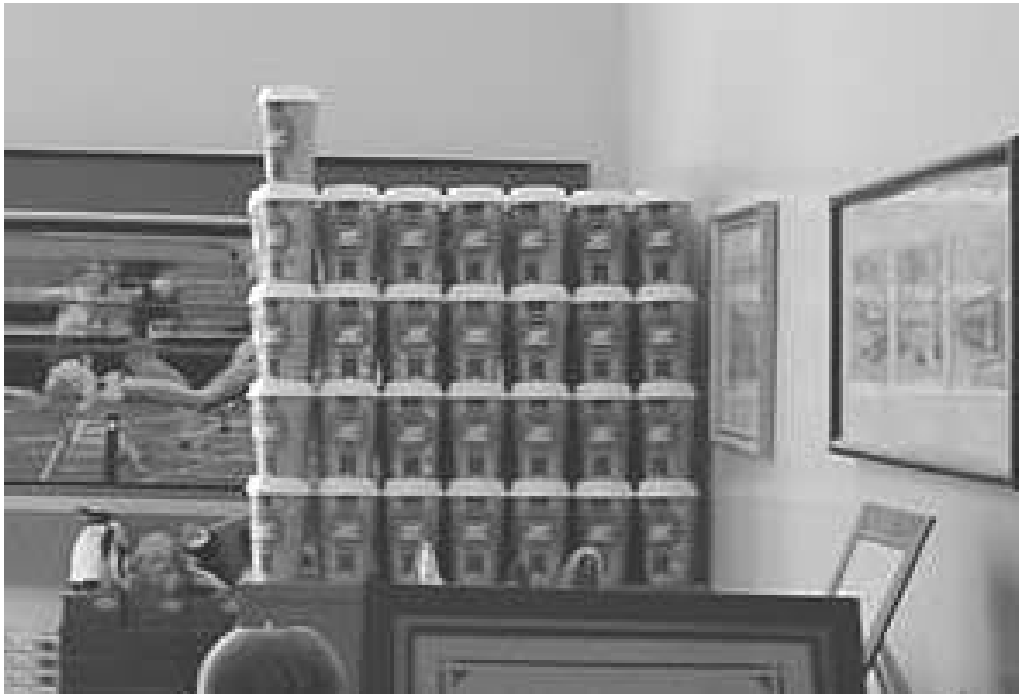
Picture 12

Although the building staff have not reported a problem with pest infestation the potential for such problems exists. Food products and stacks of coffee cups were noted in an office (see Picture 12). Residue from coffee and associated products (e.g., cream and sugar) can attract pests as well as be a source of unpleasant odors. Insect parts can become dried out and aerosolized and may serve as a source of allergenic material for certain sensitive individuals.

Stack of Used Coffee Cups in an Office

12. Activities that can be used to prevent pest infestation may include the following:
 - Rinse out recycled food/beverage containers. Seal recycled containers with a tight fitting lid to prevent access of pests.

- Remove non-food items that can attract pests.
 - Store foods in tight fitting containers.
 - Avoid eating in offices. In areas where food is consumed, periodic vacuuming to remove crumbs is recommended.

- Regularly clean crumbs and other food residues from toasters, toaster ovens, microwave ovens and other food preparation equipment.

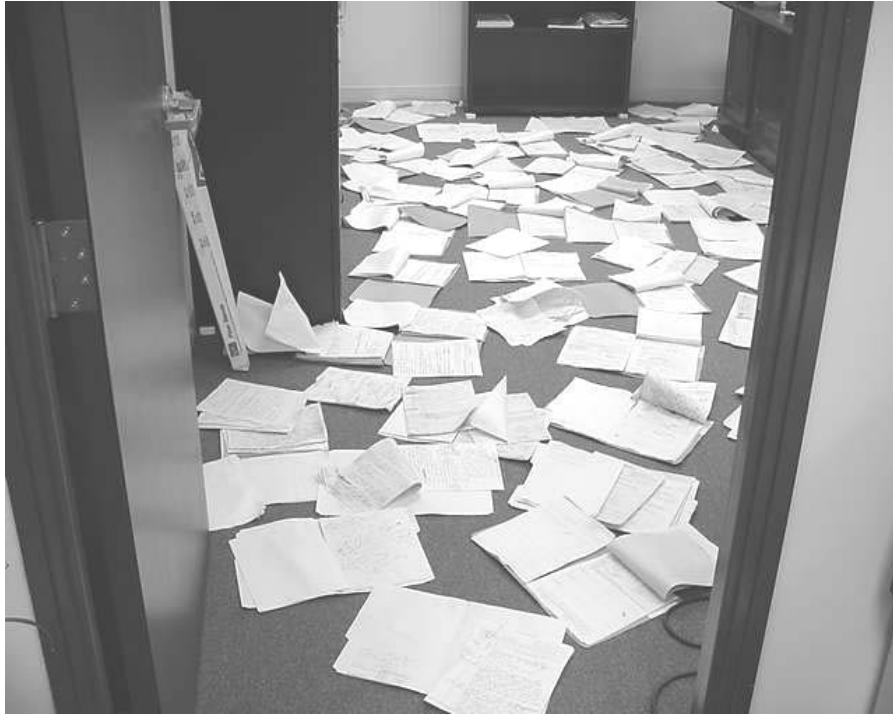
Picture 1

Substantial efforts to restore the basement to a workable environment were made by contractors as well as court facilities personnel. Exposed areas of carpet were also cleaned. Floor fans and dehumidifiers were in operation at the time of this assessment. While carpeting appears to be substantially dried out, the condition of water logged court records and gypsum wallboard remain possible problems. Substantial amounts of court records remained saturated for several days following the flood. Efforts were made by court staff to dry court records, however numerous documents remain moist (see Picture 1). If records remain moistened the likelihood of these documents serving as medium for mold growth increases with time.

Documents Drying on the Floor of the Judge's Chambers Floor

Steps should be taken to dry moistened court records. A decision should be made concerning the storage of mold contaminated materials. Boxes, documents, books and other moistened materials will become sources of mold particulates. In this case, dehumidification and ventilation alone cannot serve to reduce or eliminate mold growth in these materials. As an initial step, options concerning the preservation of materials stored in this area should be considered. Since many court records appear to be stored in this area, an evaluation concerning disposition of these materials must be made. Porous materials that are judged not worthy of preservation, restoration or transfer to another media (e.g., microfiche or computer scanning) should be discarded. Where stored materials are to be preserved, restored or otherwise handled, an evaluation should be done by a professional book/records conservator. This process can be rather expensive, and may be considered for conservation of irreplaceable documents that are colonized with mold. Due to the cost of records conservation, disposal or replacement of moldy materials may be the most economically feasible option.

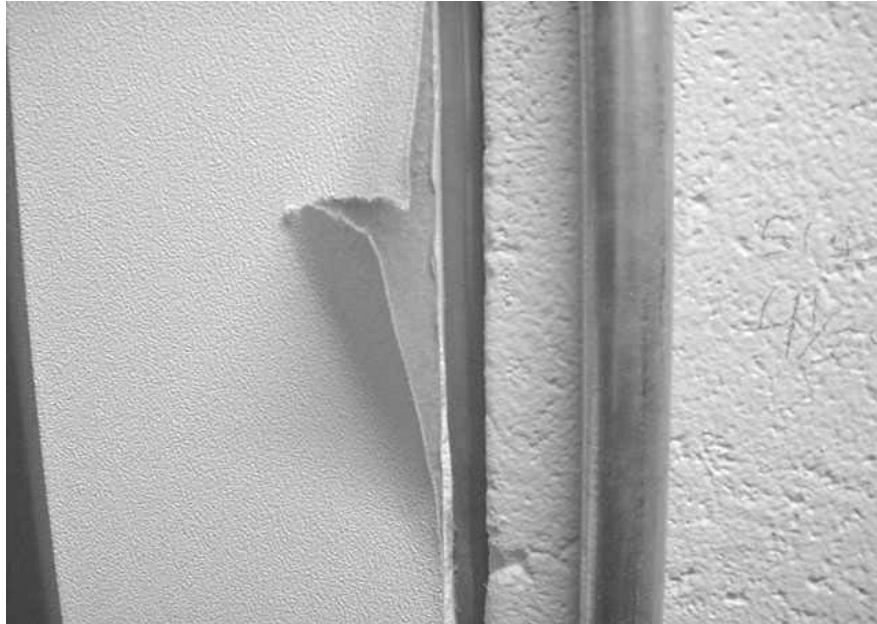
Picture 2

Wallpaper Covering Gypsum Wallboard

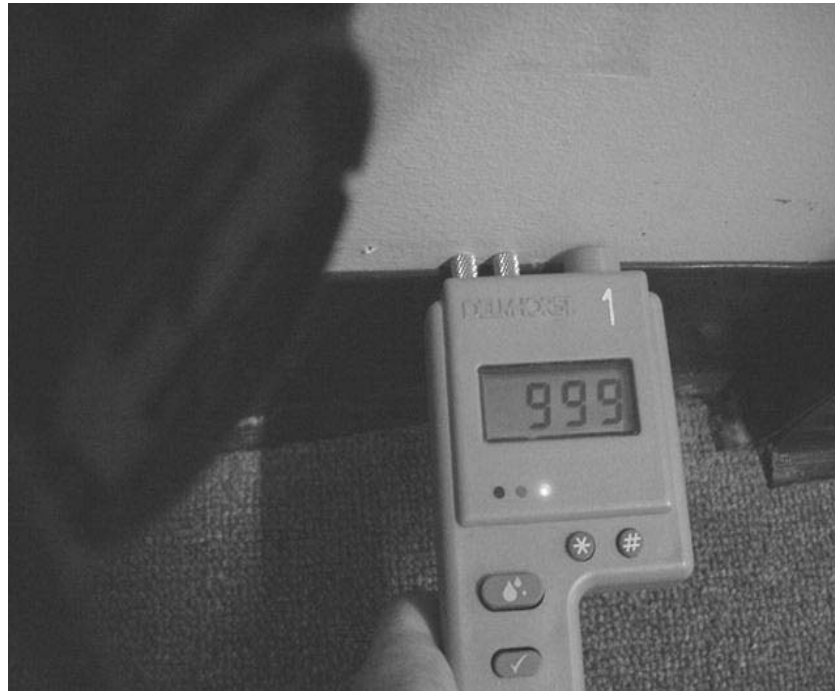
Picture 3

using a Delmhorst, BD-2000 Model, Moisture Detector. All prefabricated wall coverings were saturated with water (see Picture 3), indicating that efforts to dry this material are hindered by the wall covering. Water saturated gypsum wallboard can support mold growth if it remains moistened.

**Moisture Meter Producing A Saturated Measurement
Approximately 4-inches Above Floor in Basement**

In addition to moistened records, gypsum wallboard inside the juvenile court area should be examined and removed if found to contain mold. In order to avoid potential mold and related spore movement during remediation of the basement, the following recommendations should be implemented in order to reduce contaminant migration into occupied areas and to better understand the potential for mold to impact indoor air quality:
